## Inspection Report

4821 W Cactus Rd

Scottsdale, AZ 85143

Saturday, August 8, 2026

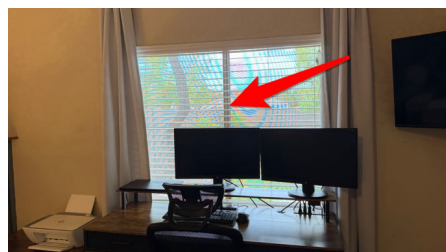
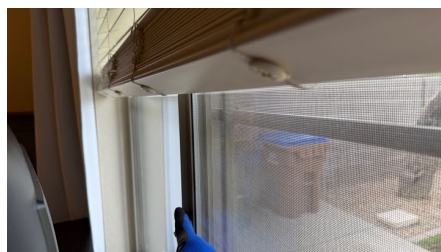
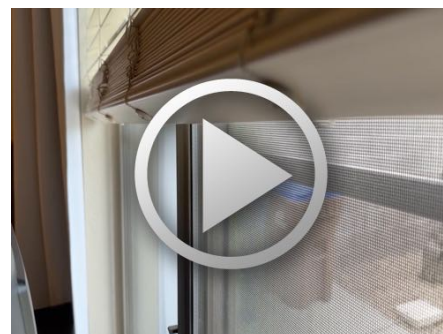
Master Bedroom

**12:** The master window frame is not secured to the glass. For safety concerns, repair by a licensed glazing contractor is recommended.

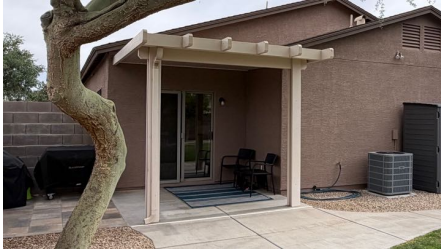
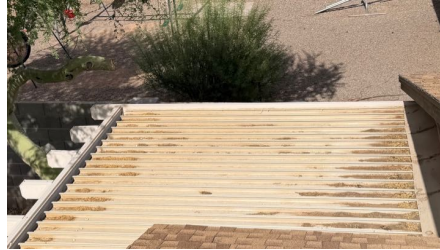
**19:** The patio cover roof has excessive debris that will hinder drainage. Ongoing cleaning will be needed.

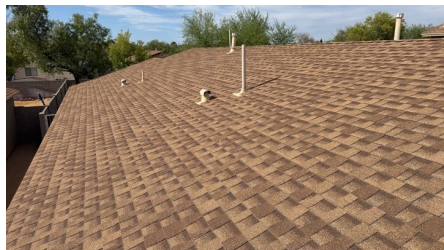
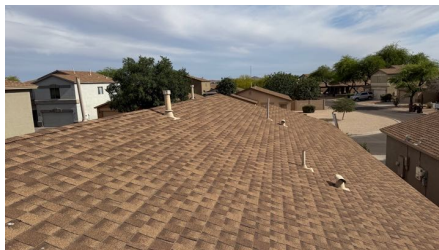
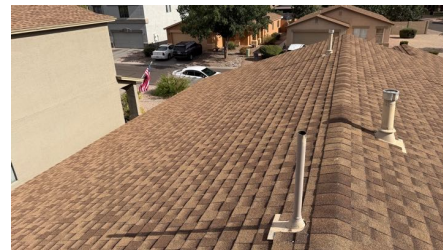
**24:** The roof material type is asphalt shingle serviceable with age related wear. The underlayment and primary flashings are concealed. Roof leaks are not predictable.

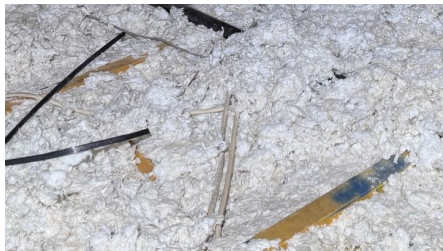
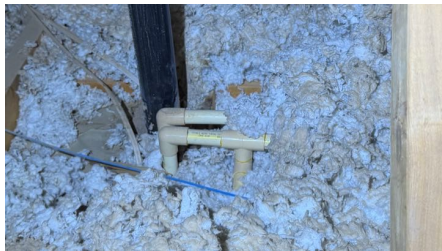
**27:** The visible water supply and distribution pipes are Chlorinated Polyvinyl Chloride (CPVC) in satisfactory condition where visible. Pipe material in walls and non accessible attic areas were not identified. Other materials may be present but were not detected at the time of the inspection.

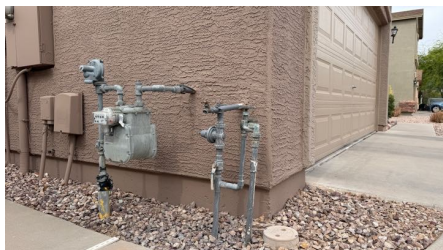
**28:** The main water valve is located at west side exterior wall and is functional - shown below.

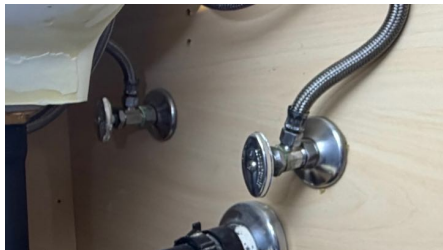
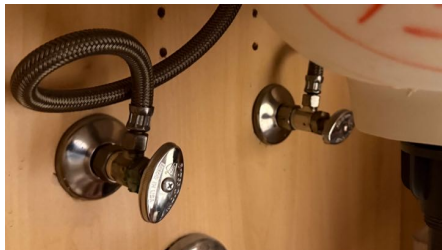
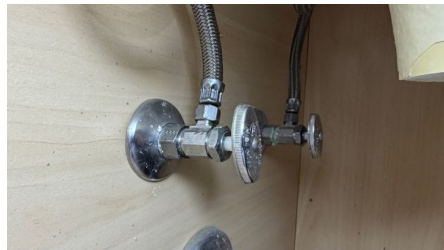
**29:** Individual angle stops and supply valves cannot be operated during home inspections. It is common for these valves to leak or break when operated and may or may not fully close. Any visible corrosion, rust or leakage, that can happen at anytime, indicates replacement is needed. For reliable service, routine operational valve evaluation and replacement as needed, by a licensed plumbing contractor, is recommended. If you want the valves to function reliably in any situation; replace all valves.

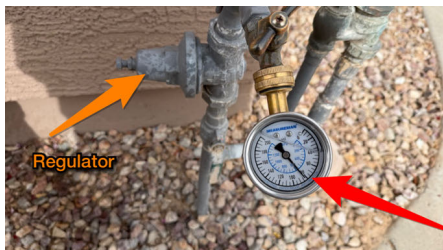
**30:** Water pressure is over 80 psi. Approximately 82 psi. This condition will stress plumbing components rated at 80 psi. To reduce the risk of plumbing rupture, regulator adjust or replacement by a licensed plumbing contractor is recommended.

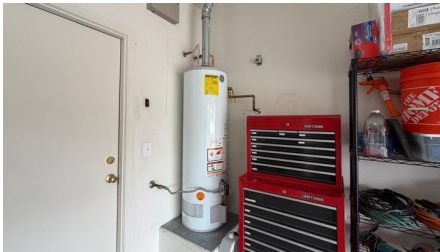
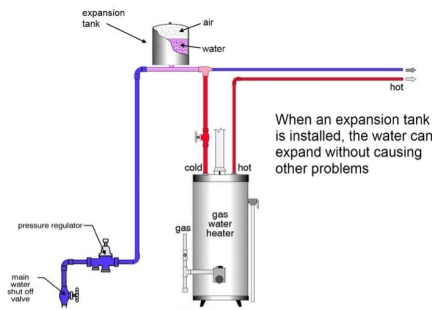
**31:** The incoming water pressure regulator creates a closed system which requires an expansion tank. An expansion tank will give the water somewhere to go when it expands. Installation by a licensed plumbing contractor is recommended.

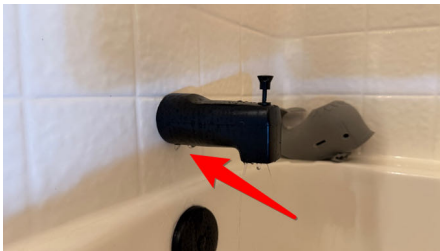
**35:** The guest bathroom tub spout drips water toward the wall. Repair is recommended to prevent water entry into the wall cavity.

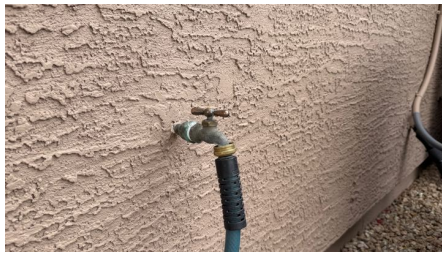
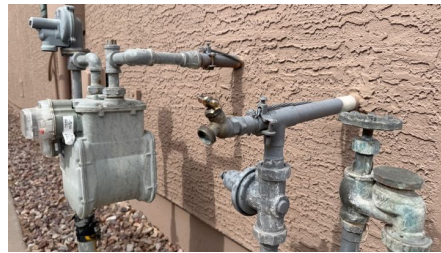
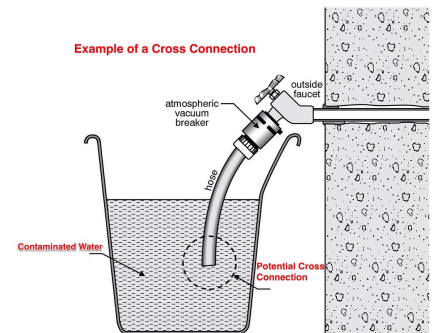
**42:** The exterior hose bibs do not have back flow prevention (vacuum breaker) devices are not installed. Back flow prevention device installation is recommended to prevent cross contamination in the event of main pressure loss.

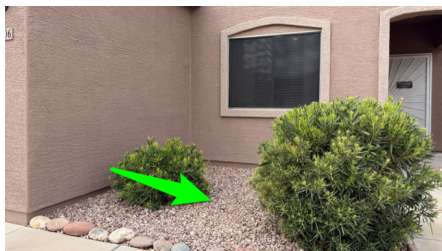
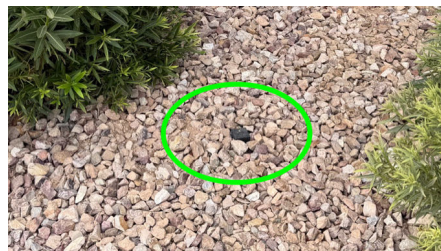
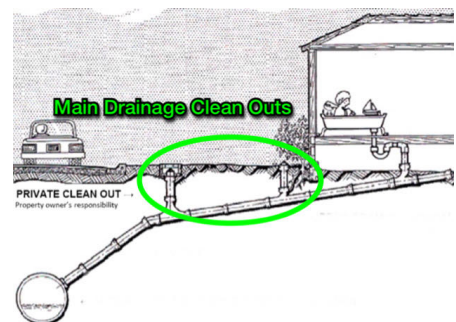
**43:** The visible portions of the drain pipes are acrylonitrile butadiene styrene (ABS) in satisfactory condition where visible. Underground and in wall in material were not identified. The main clean-out was located and is shown below.

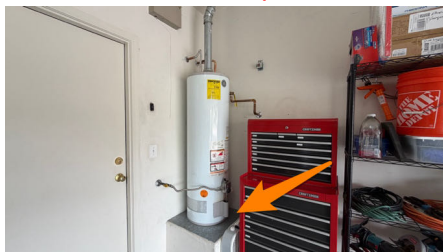
**46:** The emergency catch pan drain is not installed. While not required during original construction. Pan installation would be prudent.

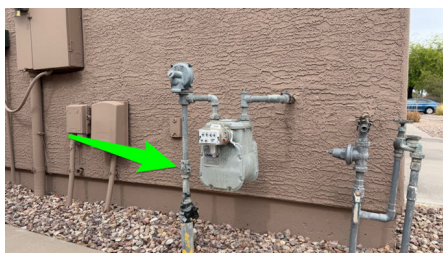
**47:** The main gas valve is located at the west exterior wall. The gas valve and piping and supports are in serviceable where visible.

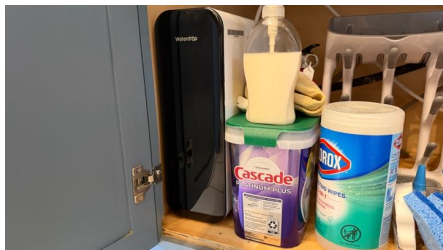
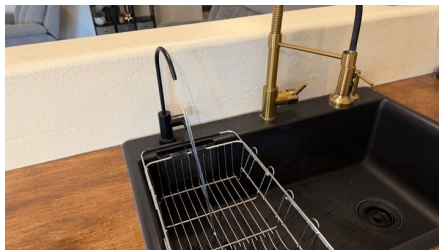
**48:** There is a filtered water system installed under the kitchen sink. Water flow was adequate during this inspection. Low water flow typically indicates filter replacement is needed. Water quality, filter condition and filtration function is beyond the scope of this inspection. Water flow is satisfactory.

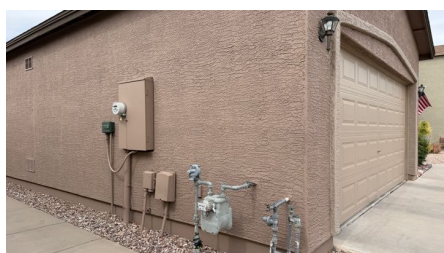
**50:** The main service panel and main overcurrent device are located at the west side exterior wall are serviceable.

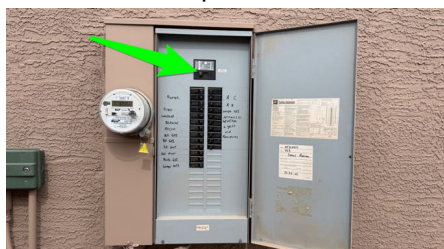
**51:** The 200 amp and 240 volt - shown below.

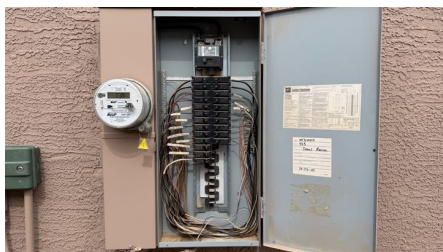
**56:** The visible branch circuit conductors are copper and stranded aluminum. Visible conductors are serviceable where visible.

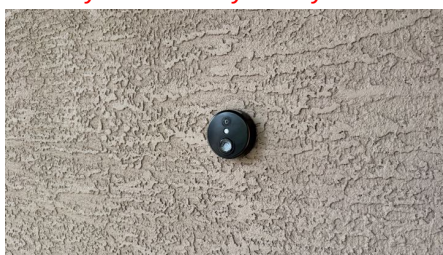
**57:** There is a SKYBELL doorbell installed. There is not a functional in house doorbell. Transfer of ownership - Factory reset ability is beyond the scope of this inspection.

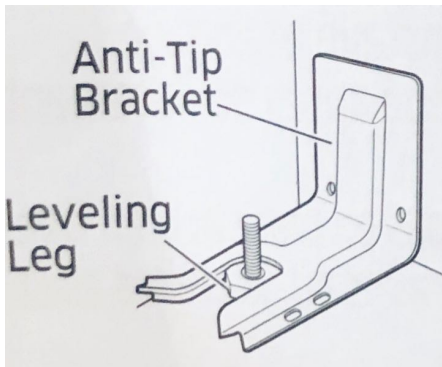
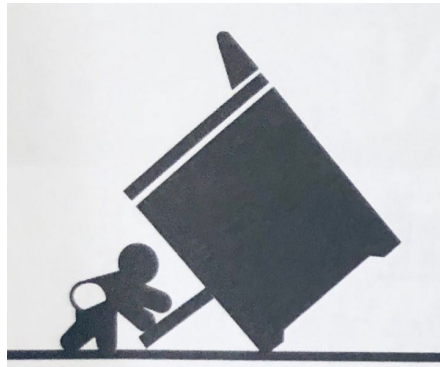
**63:** The range is not equipped with an anti-tip device, which would prevent the range from tipping, or its contents from spilling, should a child attempt to climb on it or its open door. This is a recommended safety feature, particularly if small children occupy the residence. Installation by a qualified contractor is recommended.

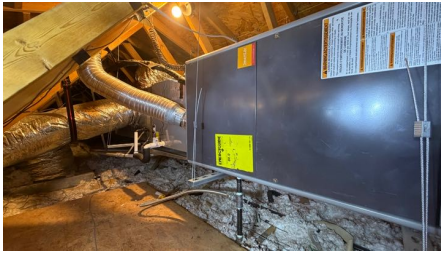
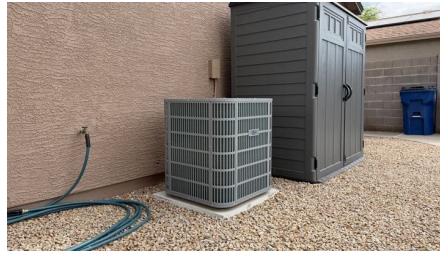
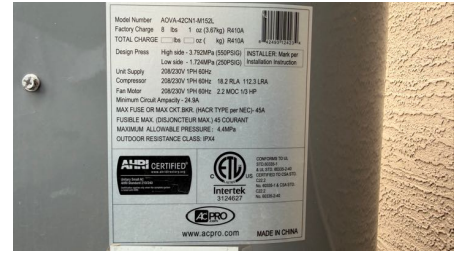
**68:** Heating and cooling are provided by one split system. Components are located at north exterior wall and attic. Electric/gas split systems include exterior electric compressing units for cooling and an internal air handler with an evaporator coil for cooling, a gas furnace for heat and a fan used year round to circulate air. The refrigerant is R410A.

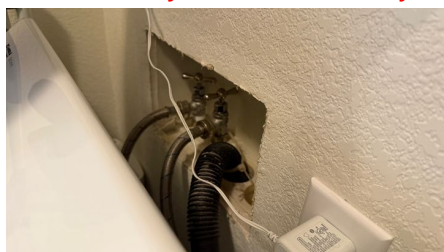
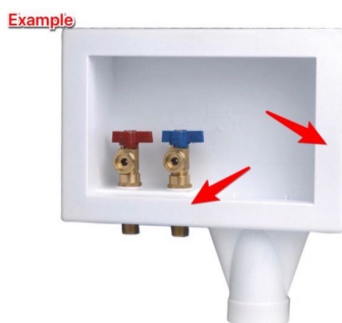
**76:** The laundry washer water valve box trim is not installed. Valve box trim should be installed to prevent moisture entry into the wall cavity.

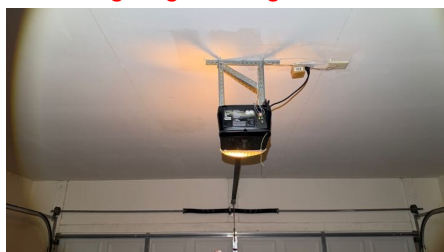
**80:** The garage ceiling and walls have typical cracks commonly found in unconditioned spaces.

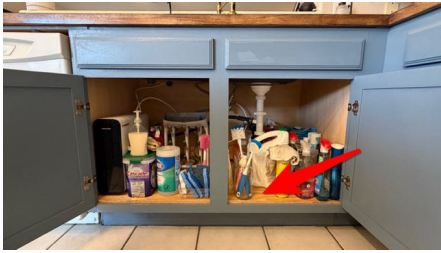
**81:** The kitchen sink cabinet floor has been replaced. Typically due to moisture damage. The areas below and behind cabinets are not visible. Disclosure request and additional evaluation by a licensed contractor is recommended.

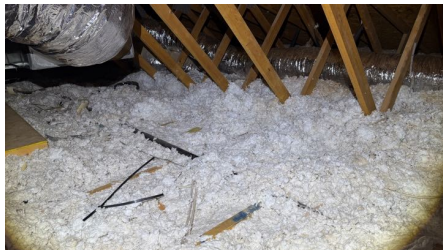
**93:** The attic is insulated with approximately 4-6 average inches of loose fiber with common low and high areas.

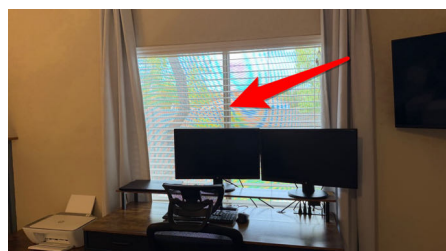
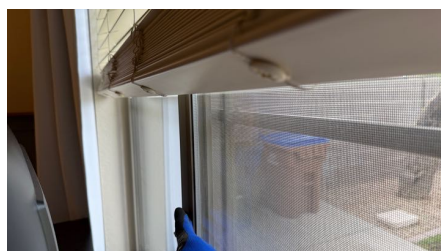
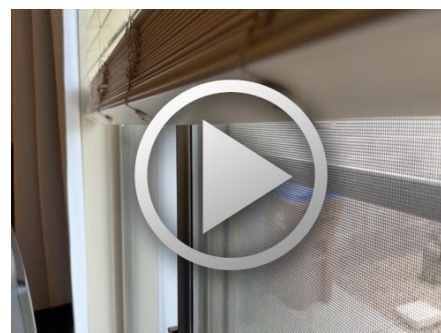
Master Bedroom

**s-12:** The master window frame is not secured to the glass. For safety concerns, repair by a licensed glazing contractor is recommended.

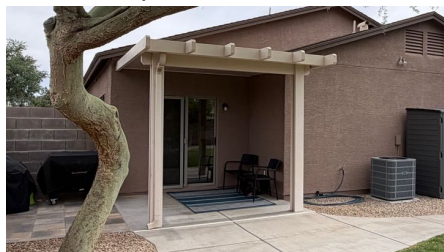
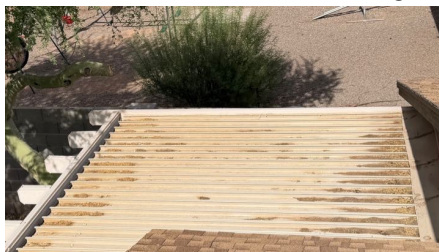
**s-19:** The patio cover roof has excessive debris that will hinder drainage. Ongoing cleaning will be needed.

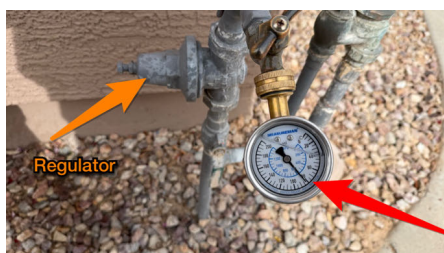
**s-30:** Water pressure is over 80 psi. Approximately 82 psi. This condition will stress plumbing components rated at 80 psi. To reduce the risk of plumbing rupture, regulator adjust or replacement by a licensed plumbing contractor is recommended.

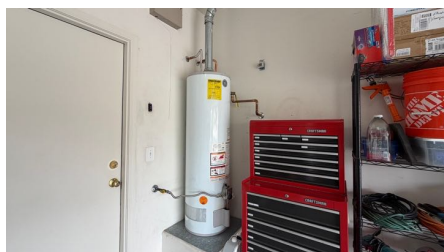
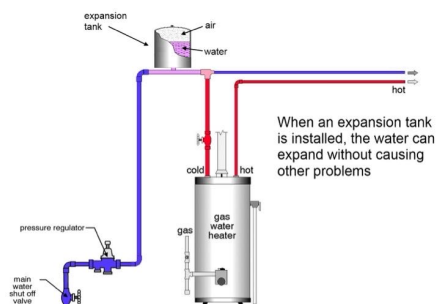
**s-31:** The incoming water pressure regulator creates a closed system which requires an expansion tank. An expansion tank will give the water somewhere to go when it expands. Installation by a licensed plumbing contractor is recommended.

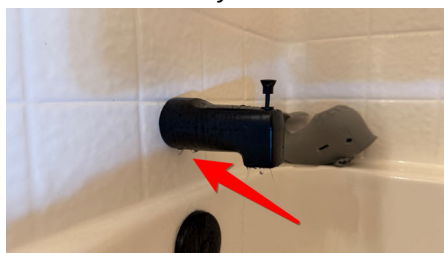
**s-35:** The guest bathroom tub spout drips water toward the wall. Repair is recommended to prevent water entry into the wall cavity.

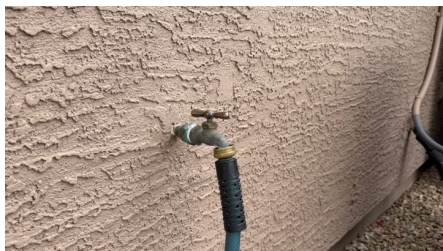
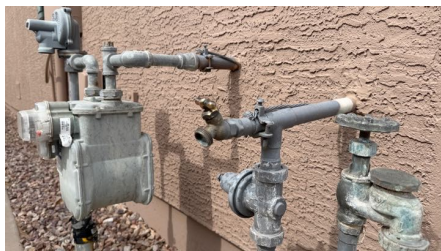
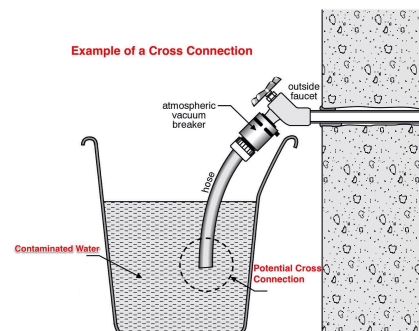
**s-42:** The exterior hose bibs do not have back flow prevention (vacuum breaker) devices are not installed. Back flow prevention device installation is recommended to prevent cross contamination in the event of main pressure loss.

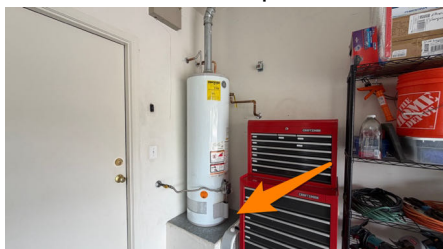
**s-46:** The emergency catch pan drain is not installed. While not required during original construction. Pan installation would be prudent.

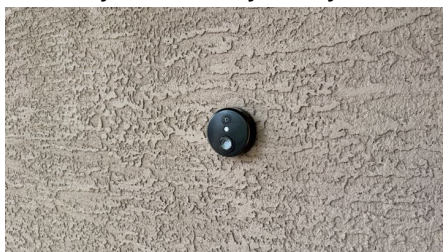
**s-57:** There is a SKYBELL doorbell installed. There is not a functional in house doorbell. Transfer of ownership  
- Factory reset ability is beyond the scope of this inspection.

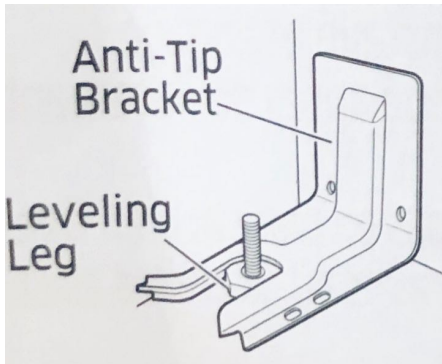
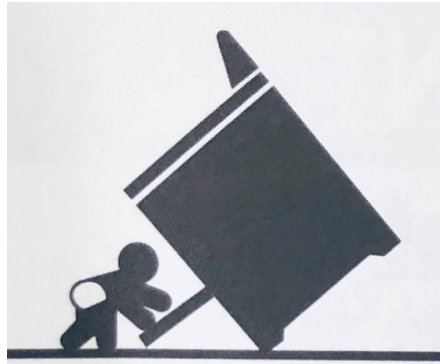
**s-63:** The range is not equipped with an anti-tip device, which would prevent the range from tipping, or its contents from spilling, should a child attempt to climb on it or its open door. This is a recommended safety feature, particularly if small children occupy the residence. Installation by a qualified contractor is recommended.

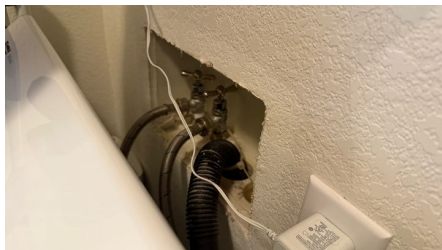
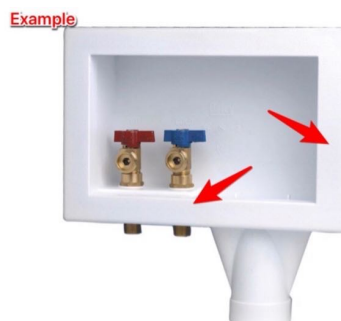
**s-76:** The laundry washer water valve box trim is not installed. Valve box trim should be installed to prevent moisture entry into the wall cavity.

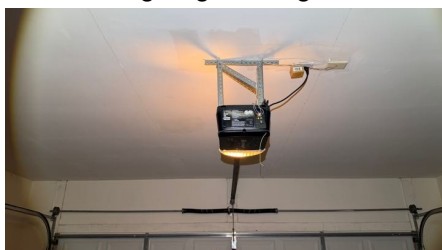
**s-80:** The garage ceiling and walls have typical cracks commonly found in unconditioned spaces.

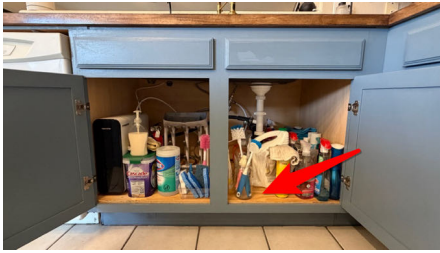
**s-81:** The kitchen sink cabinet floor has been replaced. Typically due to moisture damage. The areas below and behind cabinets are not visible. Disclosure request and additional evaluation by a licensed contractor is recommended.
